Installation Instructions and Warranty Information

Chevrolet & GMC C/K Pickup & Suburban, 5.0/5.7
1830S 1988-95 w/o AIR Inj.

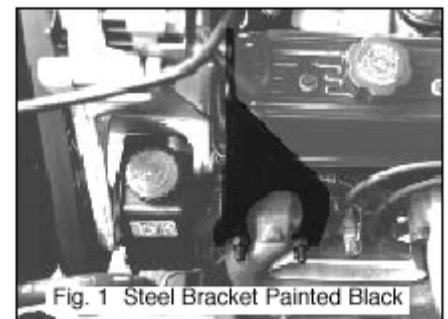
4. The power steering pump must be freed from its bracketry in order to remove the driver's side manifold. This is due to the [brilliant] design of the power steering pump/alternator bracketry. The steel bracket is fastened to the exhaust manifold studs on both sides of the front exhaust port. The studs cannot be removed until the bracket is pulled outward from the engine. The bracket cannot be pulled outward until the power steering pump is removed from the aluminum bracket. Besides, the steel bracket needs to be removed to modify it anyway! In other words, yes you really do have to go through step 5.

5. Remove the top half of the fan shroud. Remove the serpentine belt. Using a pulley remover (Snap-On CJ117A or equivalent), remove the power steering pump pulley. The three bolts on the front of the power steering pump may now be removed. Remove the bolt going from the black steel bracket into the back of the alternator. Remove the nuts holding the black steel bracket to the head on both sides of the number one exhaust port. The black steel bracket is still attached to the back of the power steering pump. The pump assembly should be loose enough to wiggle outward from the engine such that the remaining two nuts holding the steel bracket to the back of the pump can be removed. The black steel bracket should now be free.

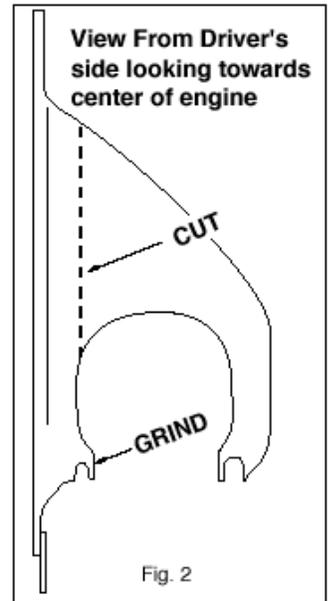
6. Remove the steel bracket. Using a hack saw, abrasive cut-off wheel, or band saw, cut the bracket as shown in figure 2. Grind the bracket for clearance as indicated in Fig 2. Clean up the edges with a file or sander and repaint.

11. Re-install the modified black steel bracket in the reverse order of removal. First, fasten the bracket to the rear of the power steering pump. Maneuver the power steering pump back into its original position. The steel bracket will now attach to the head with the single stud in the front hole of the #1 exhaust port. Attach the bracket to the head via the stud in the front hole of the #1 exhaust port. Fasten the steel bracket to the back of the alternator. Install the three bolts back through the front of the power steering pump. Reinstall the pulley using the pulley installer. (Thread the mandrel into the pump shaft. Then press the pulley back onto the pump shaft.) Re-install the serpentine belt. Re-assemble the fan shroud.

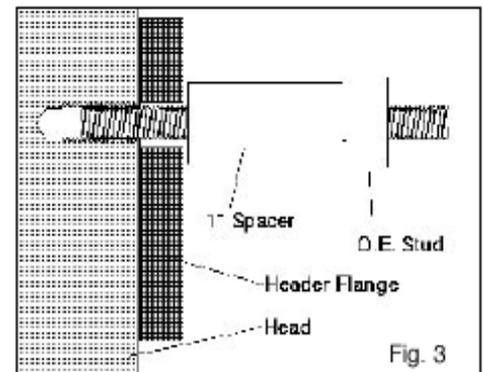
8. If your vehicle does not have an O2 sensor in the rear of the manifold, use the supplied plug to seal the O2 sensor fitting in the collector of the driver's side header. Use a sealant as described below on the threads of the plug. (Optional: Prepare the header bolts by applying anti-seize to the threads.) (Small head 3/8" x 1" bolts & lock-washers included.) On the driver's side use 5 of the 3/8" x 1" bolts supplied. Reuse one of the studs in the front hole of the #1 port. Apply a thin coating of sealant to the collector dome where it mates to the lower flange. Permatex Ultra-Copper High-Temp Sealant is recommended. DO NOT use a sealant that is not designed to be used with O2 sensors. (Also note that if excessive sealant is applied, clumps may fall into the exhaust system and clog the Catalytic Converter.) Bolt the header to the head. Use the supplied bolts and lock washers on the rear 5 bolts. Do not use a lock washer on the front hole where the stud is being re-used. Use the supplied 1" tubular spacer between the header flange and the stud shoulder on the front hole. See fig.3. Torque all 6 fasteners to factory specifications (30-35 ft./lbs.).

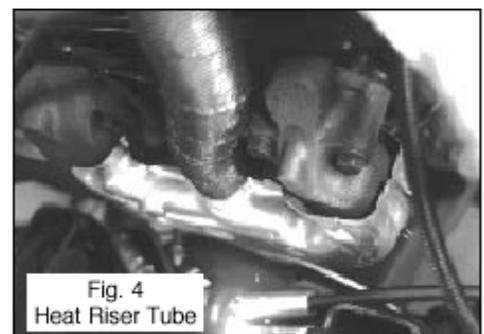
12. The Passenger Side: Unbolt the manifold from the exhaust system from under top of the manifold.) Remove the dipstick. Disconnect the spark plug wires from the spark plugs. Unbolt the Spark Plug wire looms and put them up out of the way. The dipstick tube is bolted to the head via the forward spark plug wire loom bolt. With the bolt removed, the dipstick tube can be removed by gently wiggling the tube while pulling upward. (The bottom of the tube is pressed into a receptacle in the engine.) Remove the flexible hot air tube attached to the sheet metal heat stove. (See Figure 4.) Unbolt the manifold from the head and remove. As with the driver's side, clean the head flange and lower flange where the header will attach to the exhaust system. Remember to remove the doughnut-shaped gasket.
